Field Study Photographs for Historic Preservation

The Privy at Körner's Folly, Kernersville, N.C.
February 15, 2003

James C. Burke

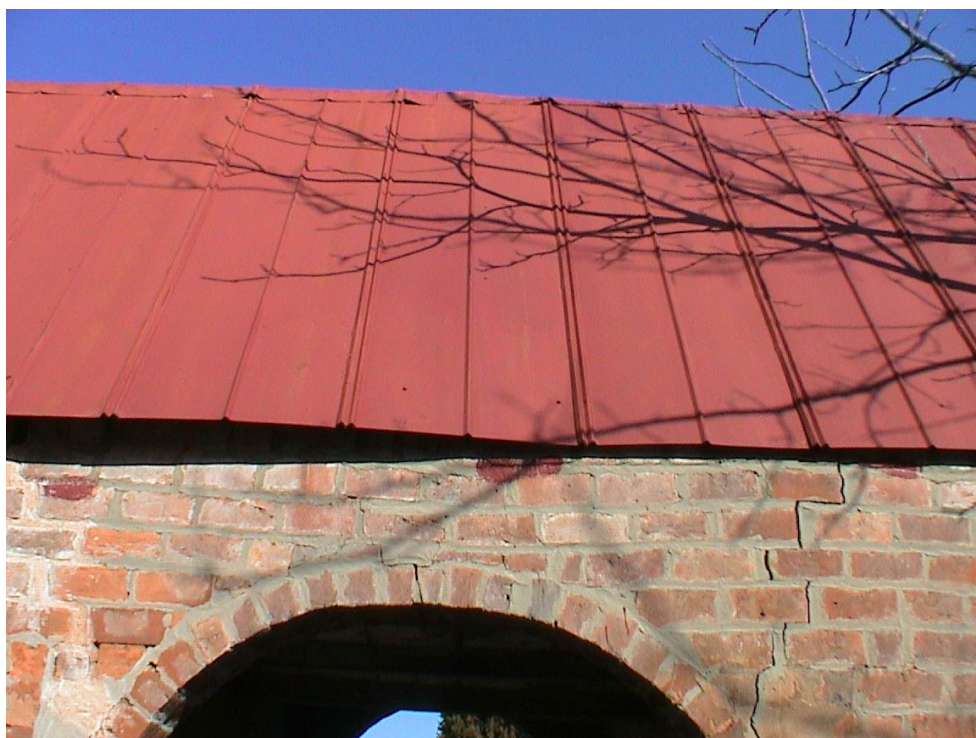
Figure 20

Rear of the privy

Structural failure

Failing mortar joints

Problem related to the use of Portland cement in earlier repointing
